ANALYSIS OF ENVIRONMENTAL DEGRADATION PATTERNS IN SELECTED MUGHAL ERA MONUMENTS FROM PUNJAB, PAKISTAN

Muhammad Tehmash Khan¹, Shakirullah², Navid Ahmad^{*3}

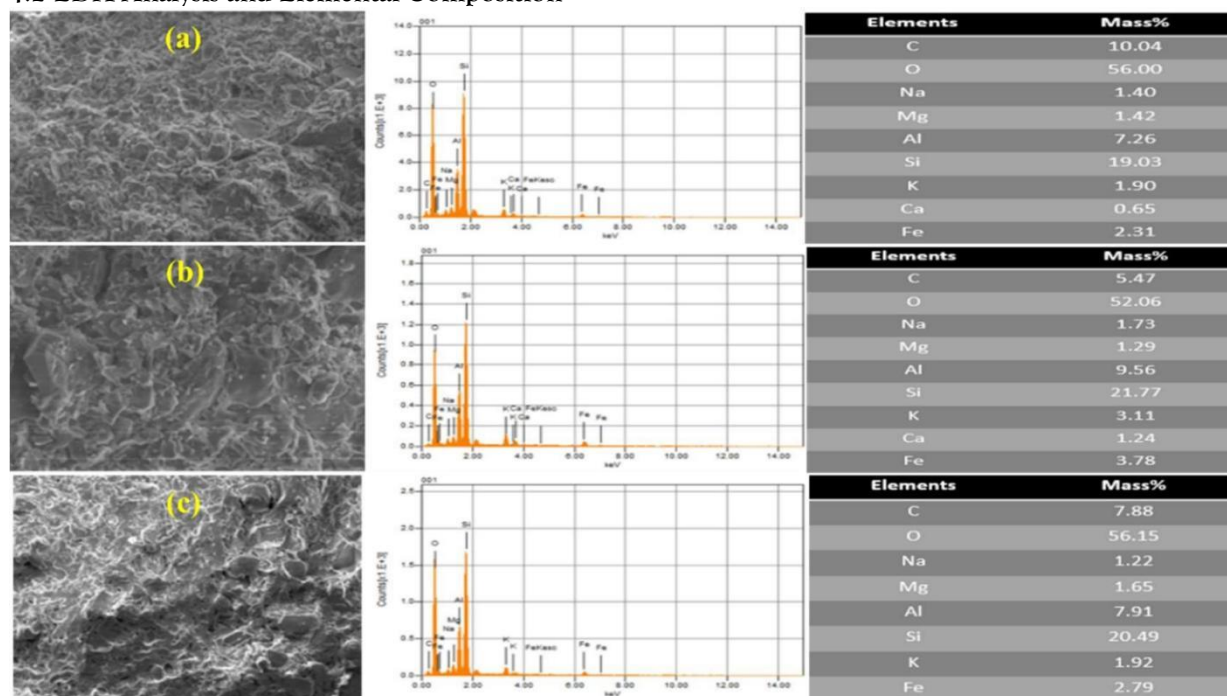
Figure 2: shows the EDX analysis of the brick's samples taken from Punjab province of Pakistan. (a) EDX analysis of sample taken from Jahangir Tomb (North courtyard) named JT-01. (b) EDX analysis of sample taken from Lahore Fort (Sheesh Mehal) named LF-03 (c) EDX analysis of sample taken from Sheikhpura Fort (Eastern gate) named SF-01.

Figure 2 EDX analysis to determine the chemical composition of bricks samples taken from Punjab site. (d), (e) and (f) showing the chemical composition of bricks samples taken from Punjab sites. All the samples contain almost similar salts

like Si, Mg, Al, Ca, Fe, C and O with promising amount which reveals that clay containing these salts in higher ratios. SEM micrographs also wetted the presence of salts on the surface of the bricks which deteriorate the bricks. In all samples from Punjab province, there is more silica present than that of samples taken from Khyber Pakhtunkhwa. Remaining illite also contained iron-bearing phases, where the grains partially melted and displayed the typical "bubble-like" porosity (Freestone & Middeltone, 1987).

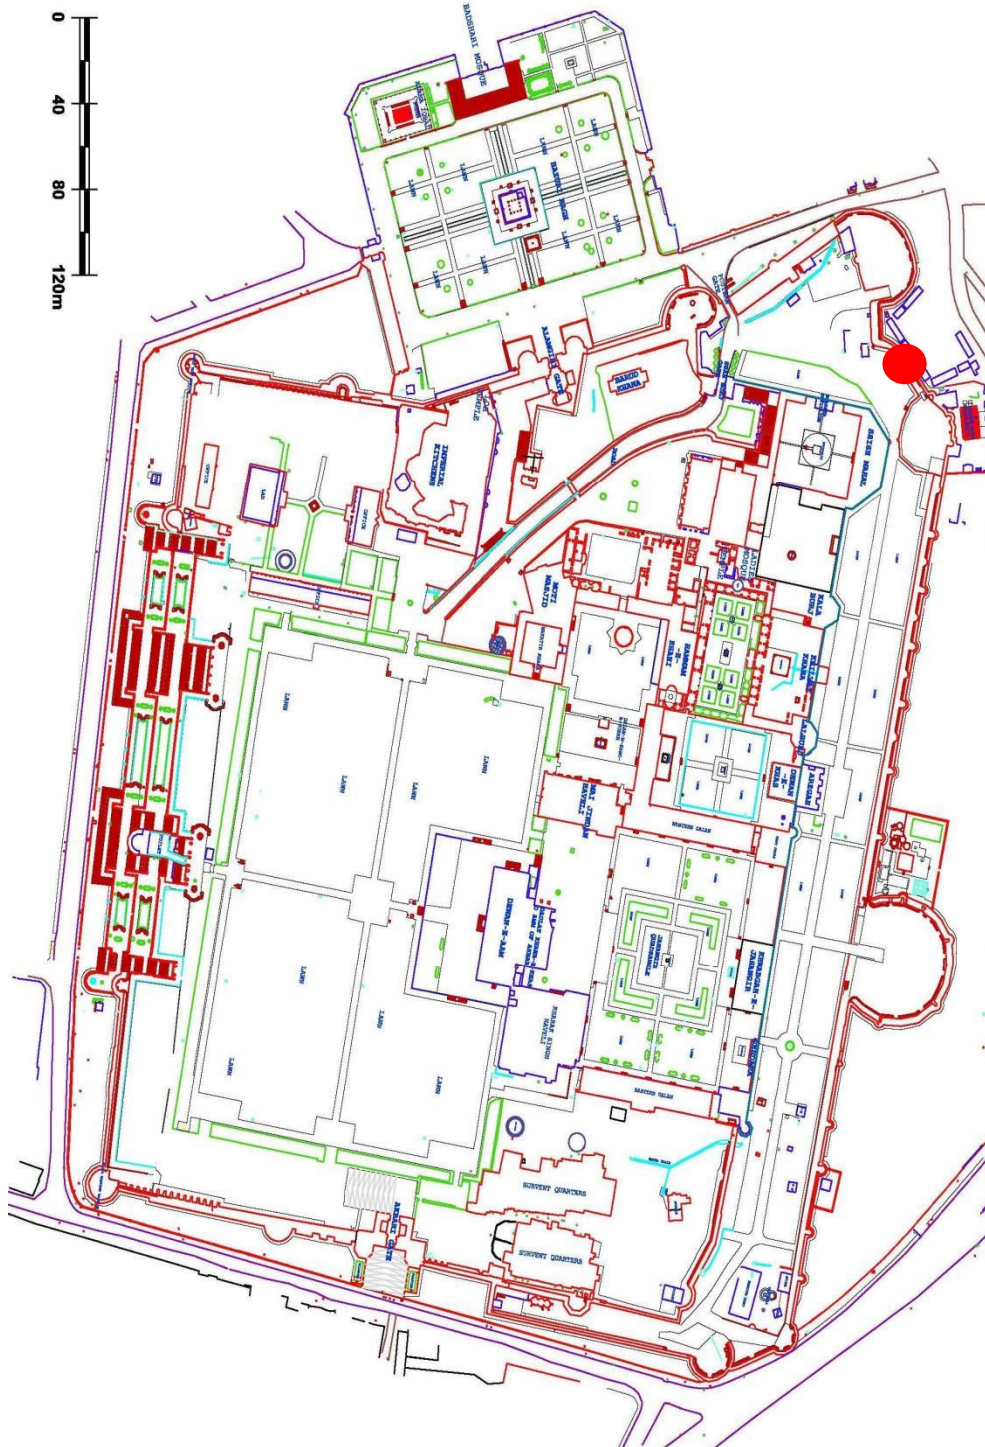
Figure.2: Old Fort, Lahore: Layout Plan and sampling area (encircled)

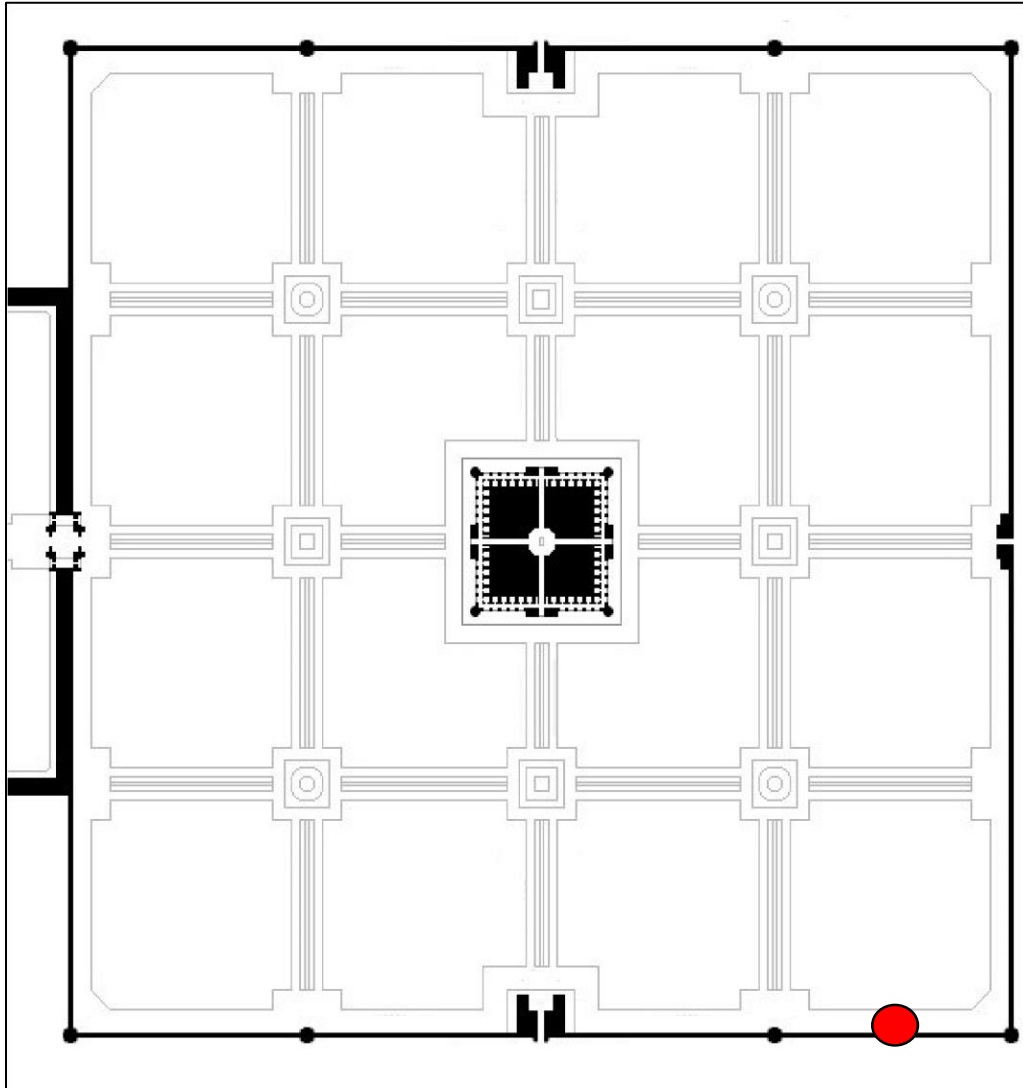
Figure.3: Jehangir Tomb, Lahore: Layout Plan and sampling area (encircled) (After KKM)
